AFFIDAVIT STANLEY A. KISKA, P.E.

Re: Larry Walker vs. Louisville Ladder

This accident involved a Davidson model D-2316-06S six-foot, type III, aluminum stepladder. It was manufactured in Monterey, Mexico approximately March 2006. The ladder currently exhibits damage to the front and rear sections, the pail shelf arms and the spreaders. Damage to the front rails consists of significant localized deformation within the first two feet of the bottom, in addition to overall twisting of the section. Damage on the rear rails can be found along most of their lengths. The rear section is currently racked from left to right relative to the front section.

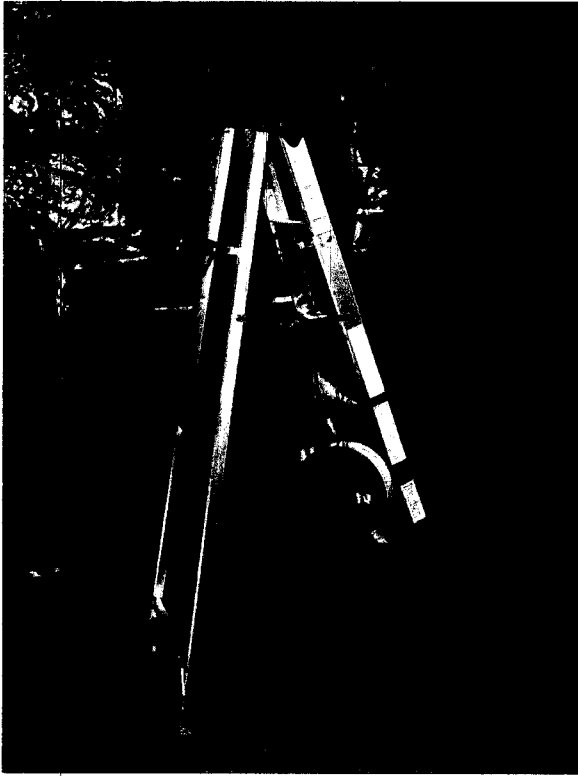
When this test was conducted on an exemplar of the subject model, flexure of the ladder was so severe and the stress on the rear leg so great that step 4 could not be fully realized. See photos below.

* Step 4 not completed. Exceptional distortion of rear rail noted under pull force load
